NORRIS, TENN.
N3607.5-W8400/7.5
1973

LANDSLIDES AND RELATED FEATURES

OF THE NORRIS, TENN. QUADRANGLE
by
Roger E. Thomas and Alfred R. Taylor
1982

U.S. Geological Survey
OPEN FILE MAP 82-653(8-16)

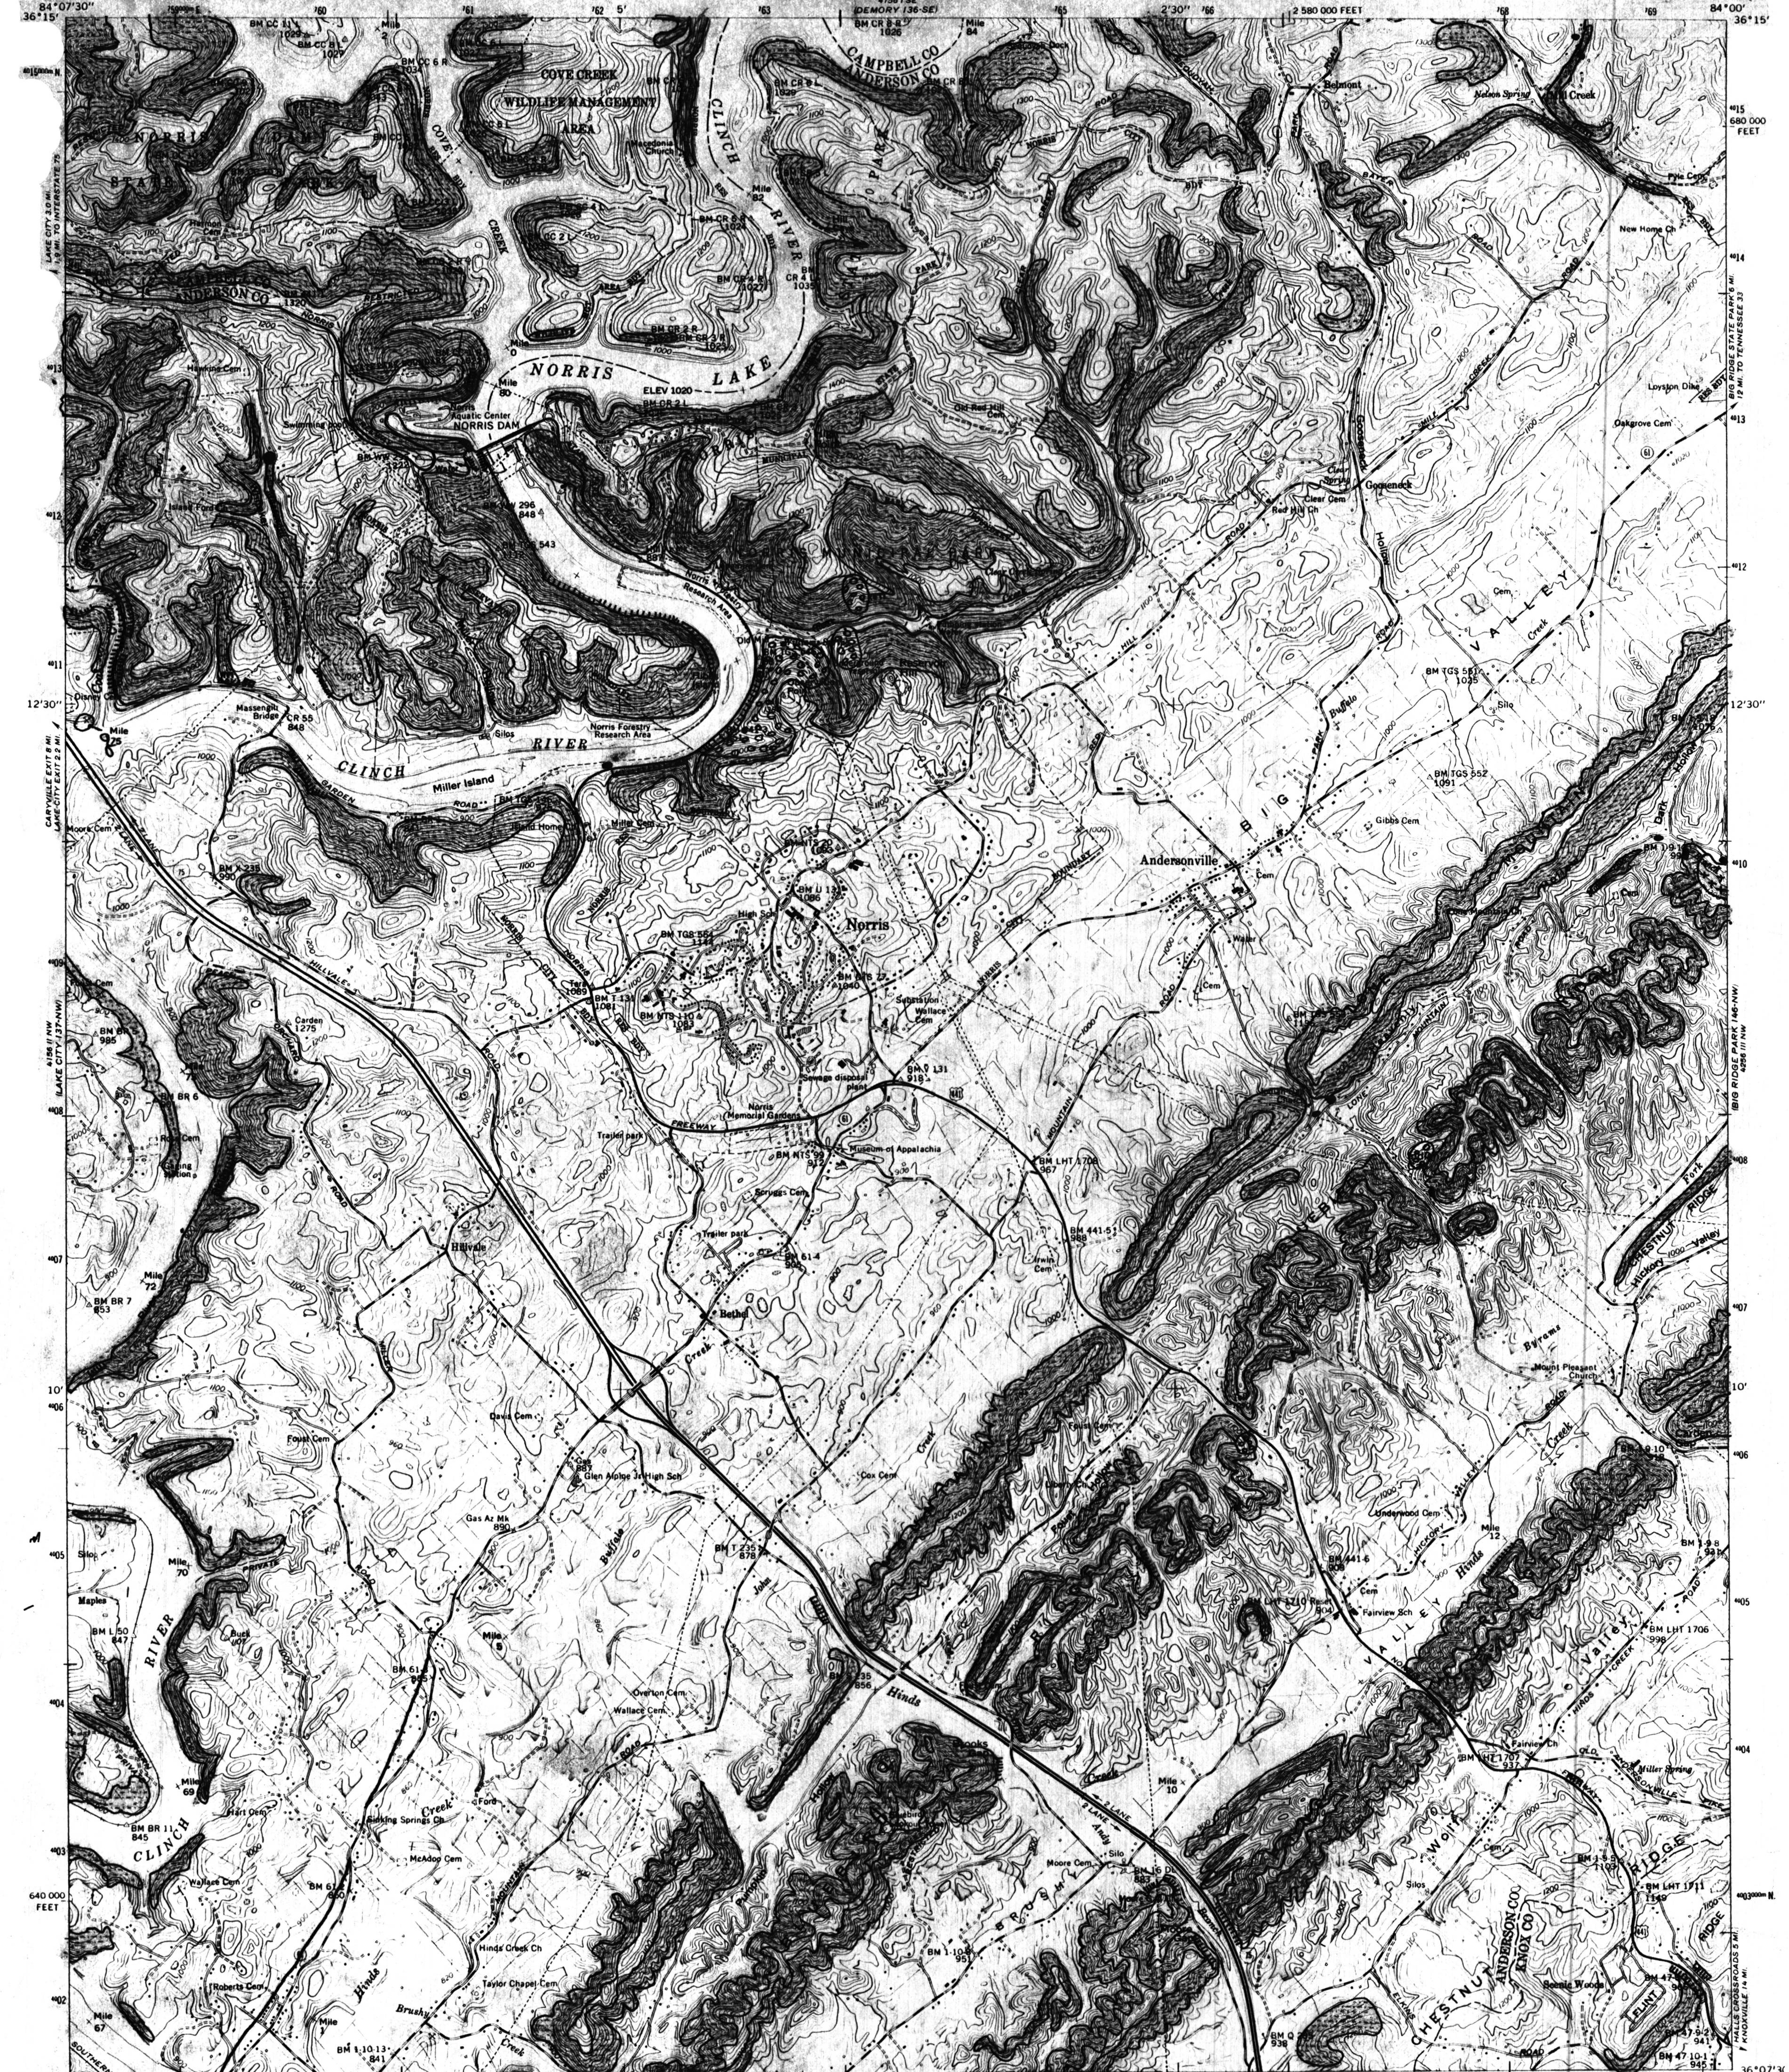
Landslides and related features interpreted
from field check 1982.

ACTIVE OR RECENTLY ACTIVE LANDSLIDE
Complex landslide composed of earthflow, debris
slide, earth and rock slump. Identified from
historical records, and from scars, debris and
other field evidence. Ground extremely unstable;
sliding accelerated by excavation, loading and
changes in drainage conditions. May include
areas with several active slides too small to
be shown separately. Questioned where doubtful.

OLD LANDSLIDE
Area of extensive hummocky ground caused by
earthflow and earth and rock slump. Lacks
clear evidence of active sliding. Relatively
stable in natural, undisturbed state,
generally not affected by small structures properly
sited in areas away from the edge of the toe;
can be reactivated by extensive, rapid exca-
vation, loading, and changes in ground water and
surface water conditions. Area of old landslide
probably includes recent ones not identified
from field evidence or otherwise documented.
Upslope boundary of landslide generally defined
by modified scarp, but downslope (toe) may be
gradational and not well defined. Questioned
where doubtful.

COMBINATION LANDSLIDE
Area of recent and old slides in which
individual slides are not identified.

COLLUVIAL SLOPE
Valley wall along major streams with slope as
steep as 40° (85%); stony, clayey silt soil up
to 50 ft. (15 m) thick; commonly buttressed by
a terrace or bench at the toe of the slope; very
susceptible to sliding by cutting of toe area,
removal of terrace or bench, and overloading;
slide commonly activated without apparent cause.

COLLUVIAL SLOPES WITH LANDSLIDES
Landslides too small or obscure to map
individually.

**AREAS SUSCEPTIBLE TO DEBRIS FLOWS AND DEBRIS
AVALANCHES**
Primarily shallow, narrow ravines and chutes with
accumulation of stony colluvium generally 10 ft.
(3 m) or less in thickness; susceptible to rapid
movement during intense rainfall. Most ravines
and chutes designated show evidence of former
debris flows and avalanches.

AREAS SUSCEPTIBLE TO ROCKFALL
Steep, locally vertical, natural and man-made
slopes and cliffs, 15 ft. (4.5 m) or more high;
formed dominantly of sandstone, limestone, sandy
shale, mudstone and claystone. Interbedded mud-
stone, claystone and shale weather rapidly leaving
sandstone and limestone rock faces unsupported.

SOIL AND ROCK SUSCEPTIBLE TO LANDSLIDING
Soil and rock similar to that involved in land-
slides elsewhere in map area; primarily areas
underlain by claystone, mudstone and shale
associated with other rock types. Rock weathers
rapidly on exposure forming clayey soil highly
susceptible to sliding. Includes coves (U-shaped,
shallow valleys) containing thick layers of clayey
soil that are very susceptible to sliding where
excavation breaks continuity of slope and where
overloaded by artificial fill.

AREAS LEAST PRONE TO LANDSLIDES
Map areas in which no patterns or symbols are shown;
primarily valley floors, ridge tops and broad
benches; modification by excavation and fill may
lead to local landslides.

NOTE
Information shown is intended as a
general guide to ground conditions as of
the date of field check. Additional
landslides and rockfalls should be anticipated
in all map units. The map unit depicts
the dominant condition in the area delineated
and variations in slope stability may occur
at any point in the unit. This map is suit-
able for general planning purposes and as a
supplement to more detailed studies for site
selection. The map cannot be used as a sub-
stitute for detailed geologic and engineering
investigations to establish design and
construction criteria of specific sites.
Some symbols may not appear on this map
because the description is applicable to a
series of maps.
